Manhole Inspection Summary

Manhole # S41E__040MH

Insp Date: **2/19/09 1:18 PM**

Location Address: **4 S CENTRAL AVE**

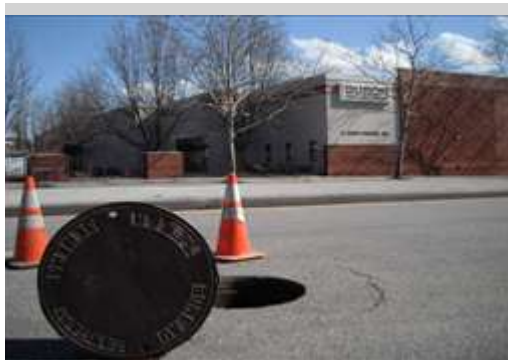
Location View

LOOKING ACROSS S CENTAL AVE

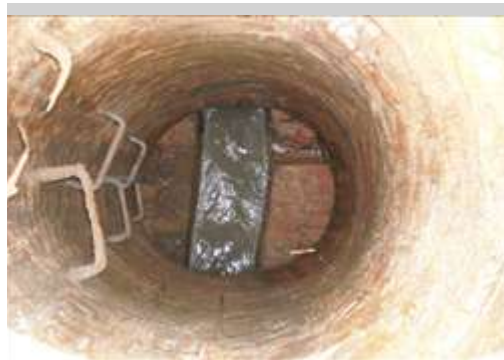
Top View

Comments **OBSERVED THAT MH LID WAS STUCK IN ADJUSTABLE FRAME. LIFTED OUT FRAME AND REMOVED LID BY USING 16LB SLEDGE. CLEANED INSIDE OF FRAME AND REPLACED ADJUSTABLE FRAME. PLACED NEW 24" LID BY REI/DRAYCO. INSPECTION COMPLETE.**

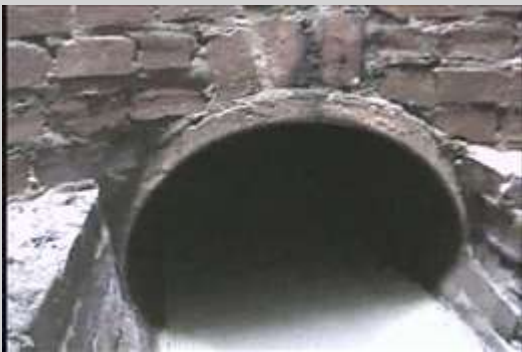
12 O'Clock Outflow

21 in. Circular Gravity Sewer
Pipe Out @ 12 O'Clock

Pipe Height: **21.6** (in.) Rod and Bar (Angled)
Pipe Material: **Clay** ☐ Pipe Lined
Invert Depth: **12.42** (ft.) Flow Characteristics: **Fast**
Deposits: ☒ None ☐ Mud ☐ Sludge ☐ Debris ☐ Grease
Silt Depth: **0** (in.) Deposits Extent:
Infiltration: **None** Pipe Seal Cond: **Sound**
